United States  
Department of  
Agriculture  
Forest Service

Forest  
Products  
Laboratory

FPL 313  
1979

# Hardwood Press-Lam Crossties: Processing and Performance

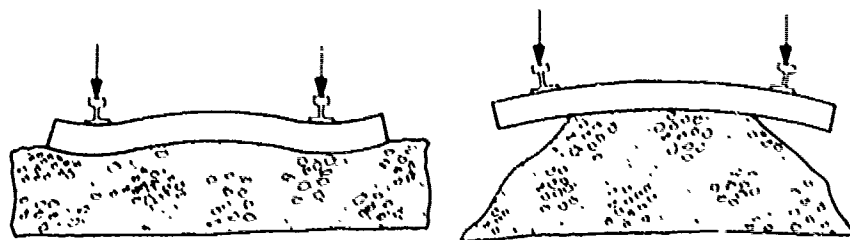
Figure 2.—Loading modes to which a cross tie is subjected

Left. Ballast remains essentially in place. Shear and flexure properties are equally important.

Right. Centerbind is caused by erosion of ballast from beneath railseats. Flexure is the critical loading mode.

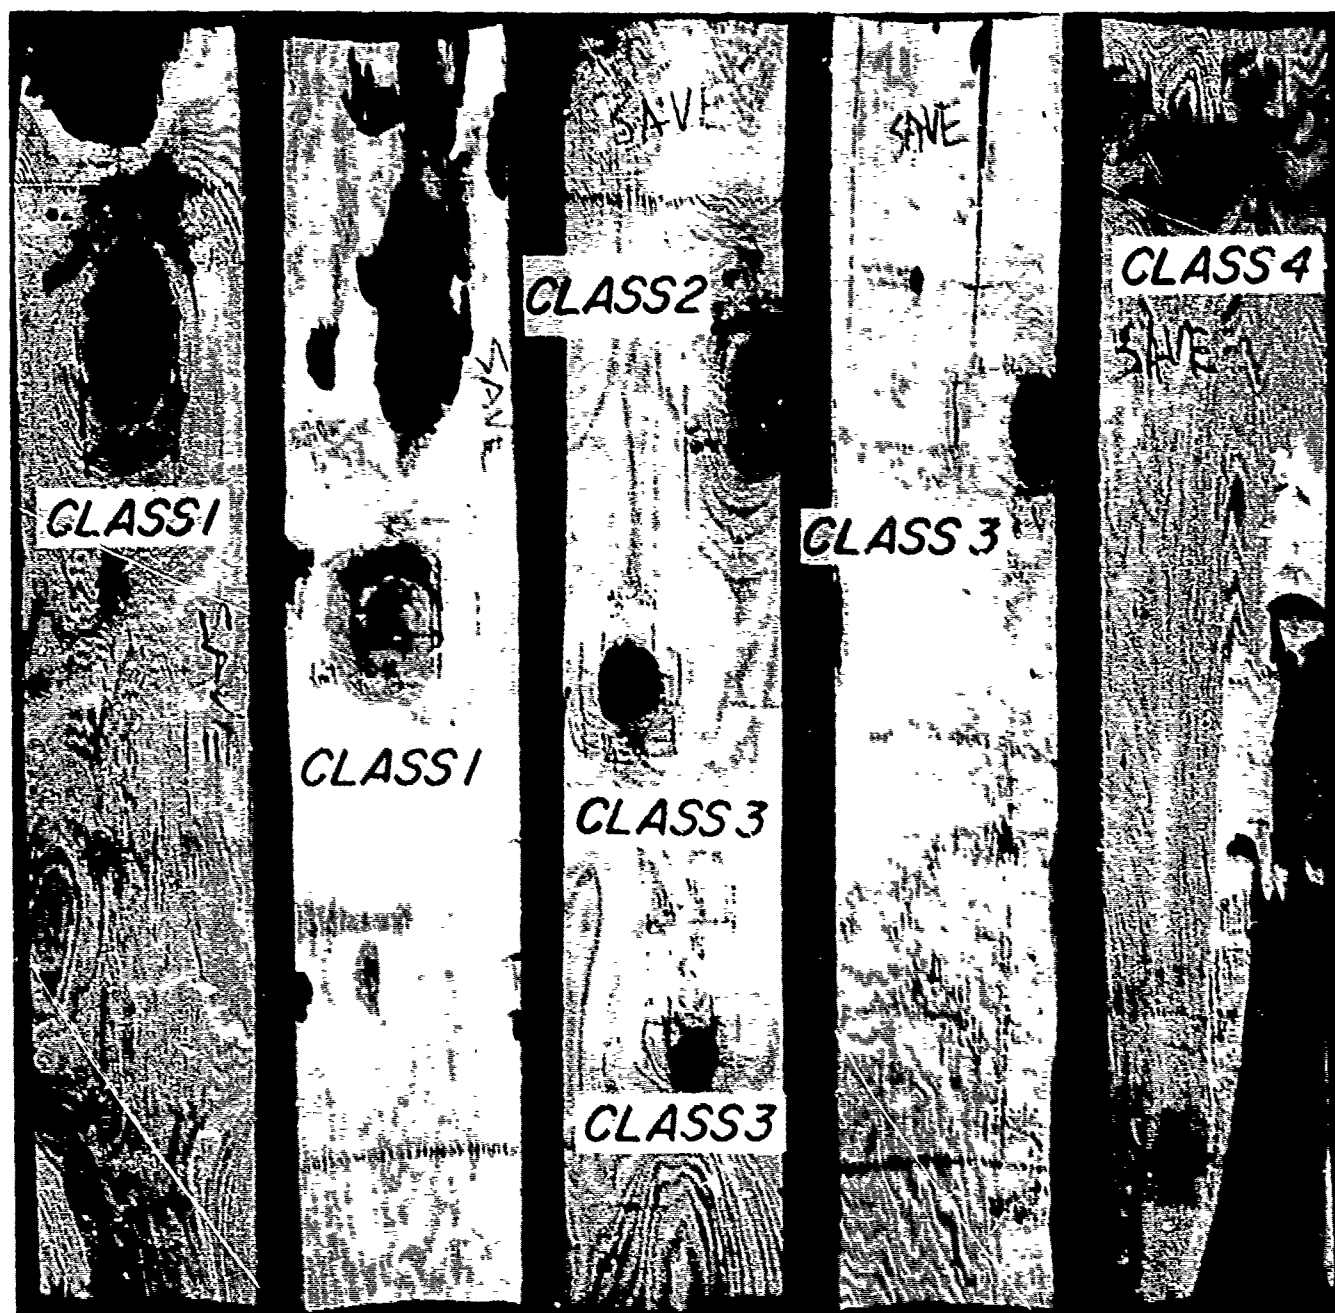
Figure 3 — Classification of knots in typical 10-inch-wide by 4-foot-long red oak veneer. Knot diameter and grain deviation expressed as a fraction of veneer width. The veneer shown was not used in tests because of wane.

All of the 0.40-inch-thick veneer from 4-foot 3-inch bolts was squared to 49 inches in length after cutting, graded for knot size classes (fig. 3), and press dried in sets of four in a 50- by 50-inch press with vented cauls at 375° F, 50 psi.

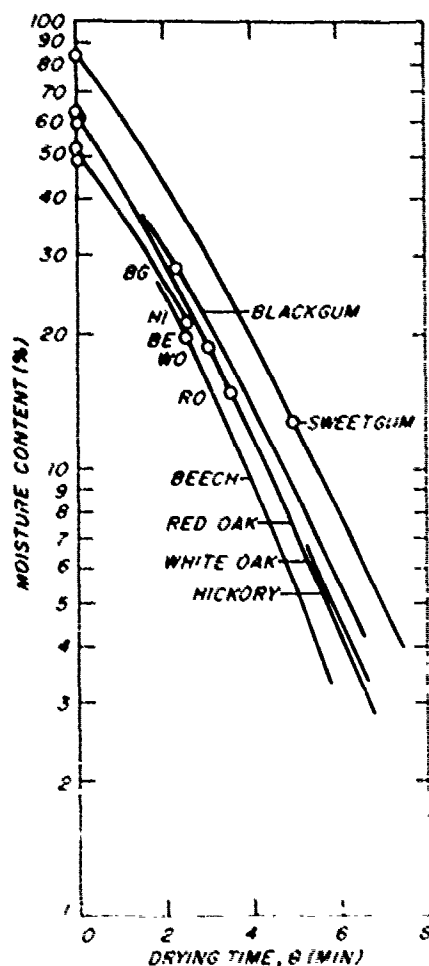
Figure 4.—Moisture content changes in 8.5-foot veneers during press drying at 375°F, 50 psi ( $l = 0.25$  in.).

approaching 20 percent. This was a compromise inasmuch as there was considerable variation of the moisture content within a species as well as the usual heartwood and sapwood presence. Based on this limited data and past experience, drying curves were developed (fig. 4 and 5). For each given species and thickness, all veneer

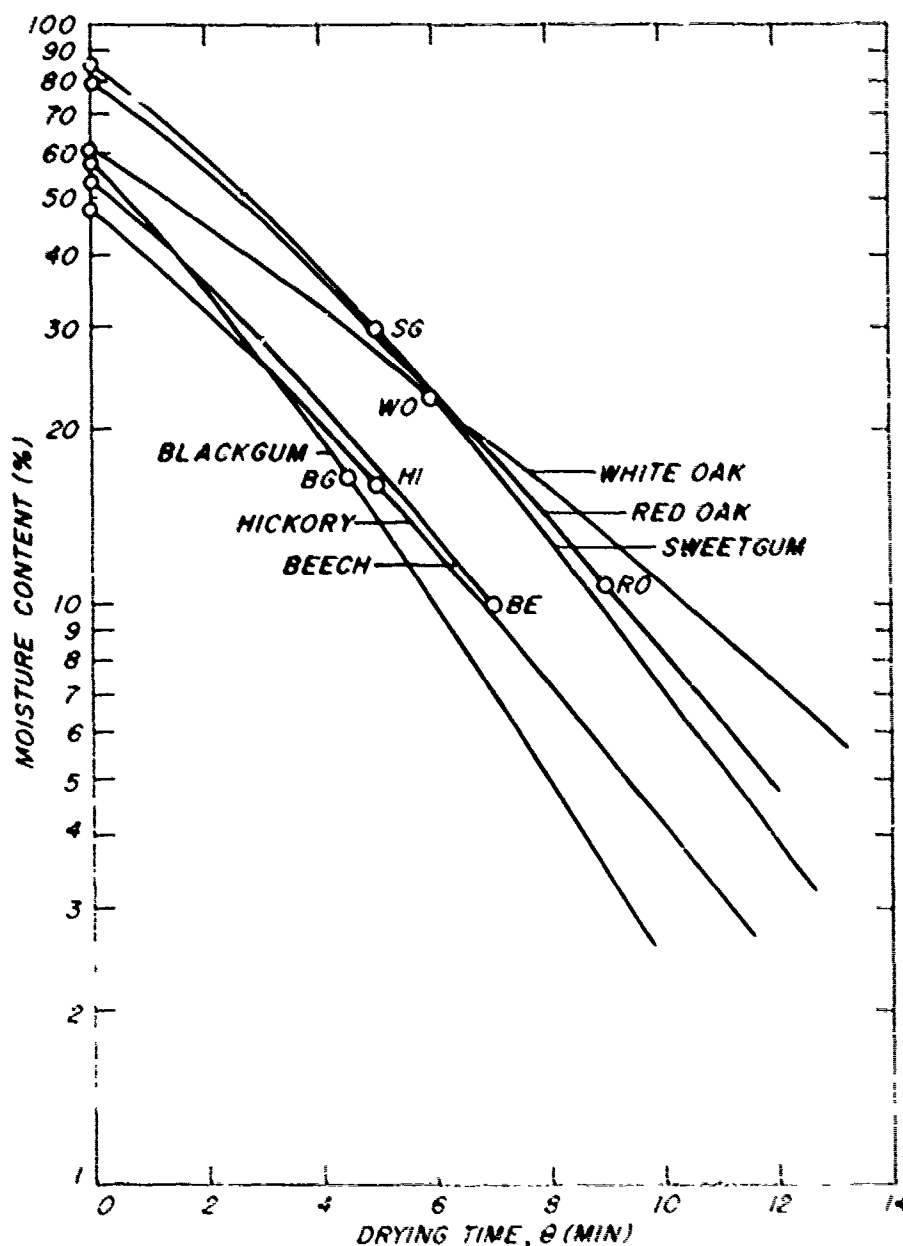
Figure 5.—Moisture content changes in 8.5-foot veneers during press drying at 375°F, 50 psi ( $l = 0.40$  in.).

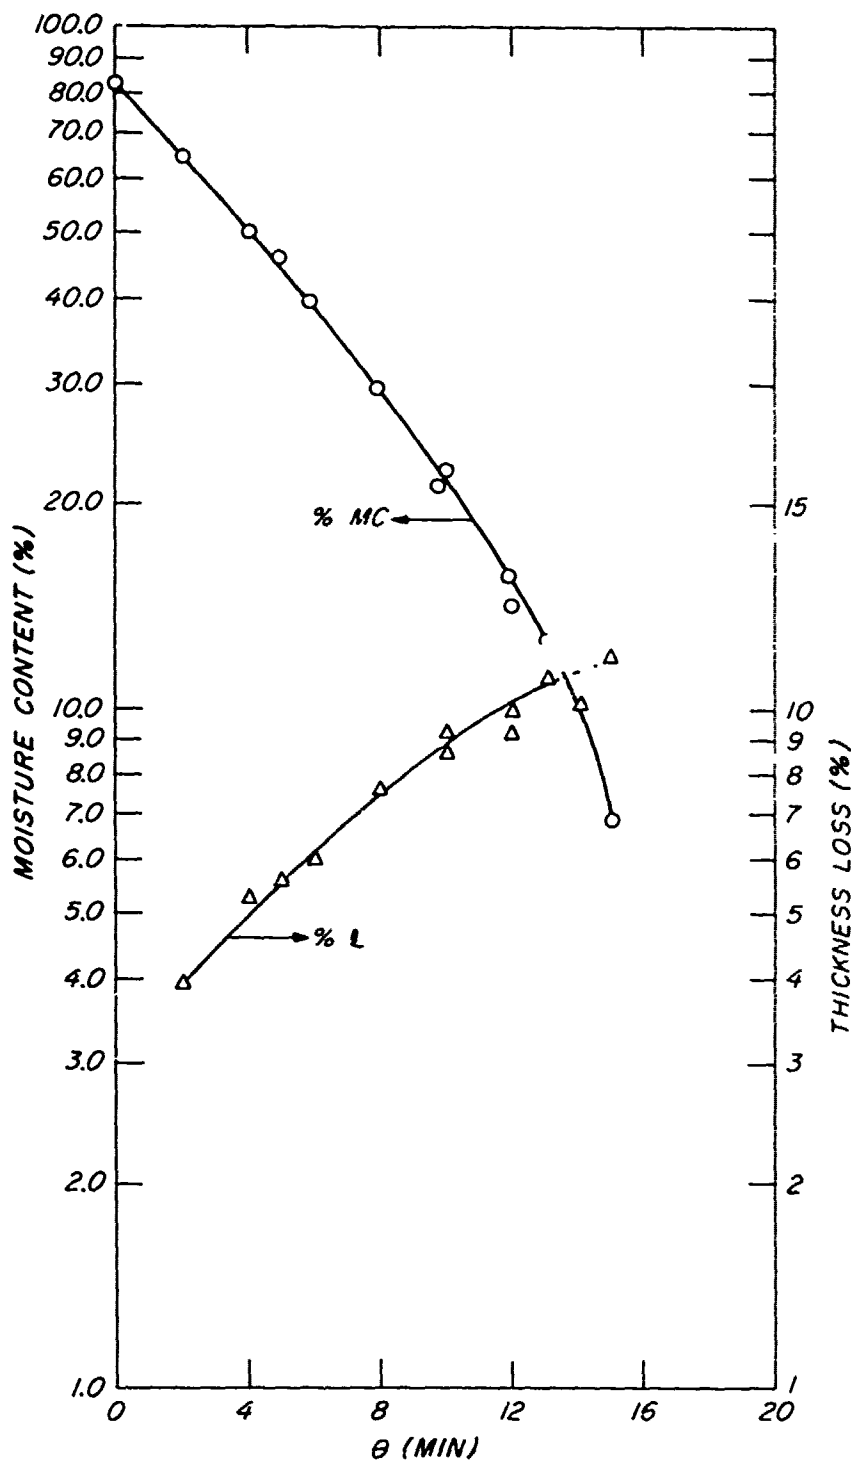
Figure 6.—Press drying and thickness loss curves for red oak veneer as functions of drying time  
(10 in. x 48 in. x 1)  
 $M_o = 81.5$  percent  
 $t_o = 0.400$  inch  
Press: 50 inches by 50 inches (vented cauls), 375° F, 50 psi.  
Each data point average of four boards.

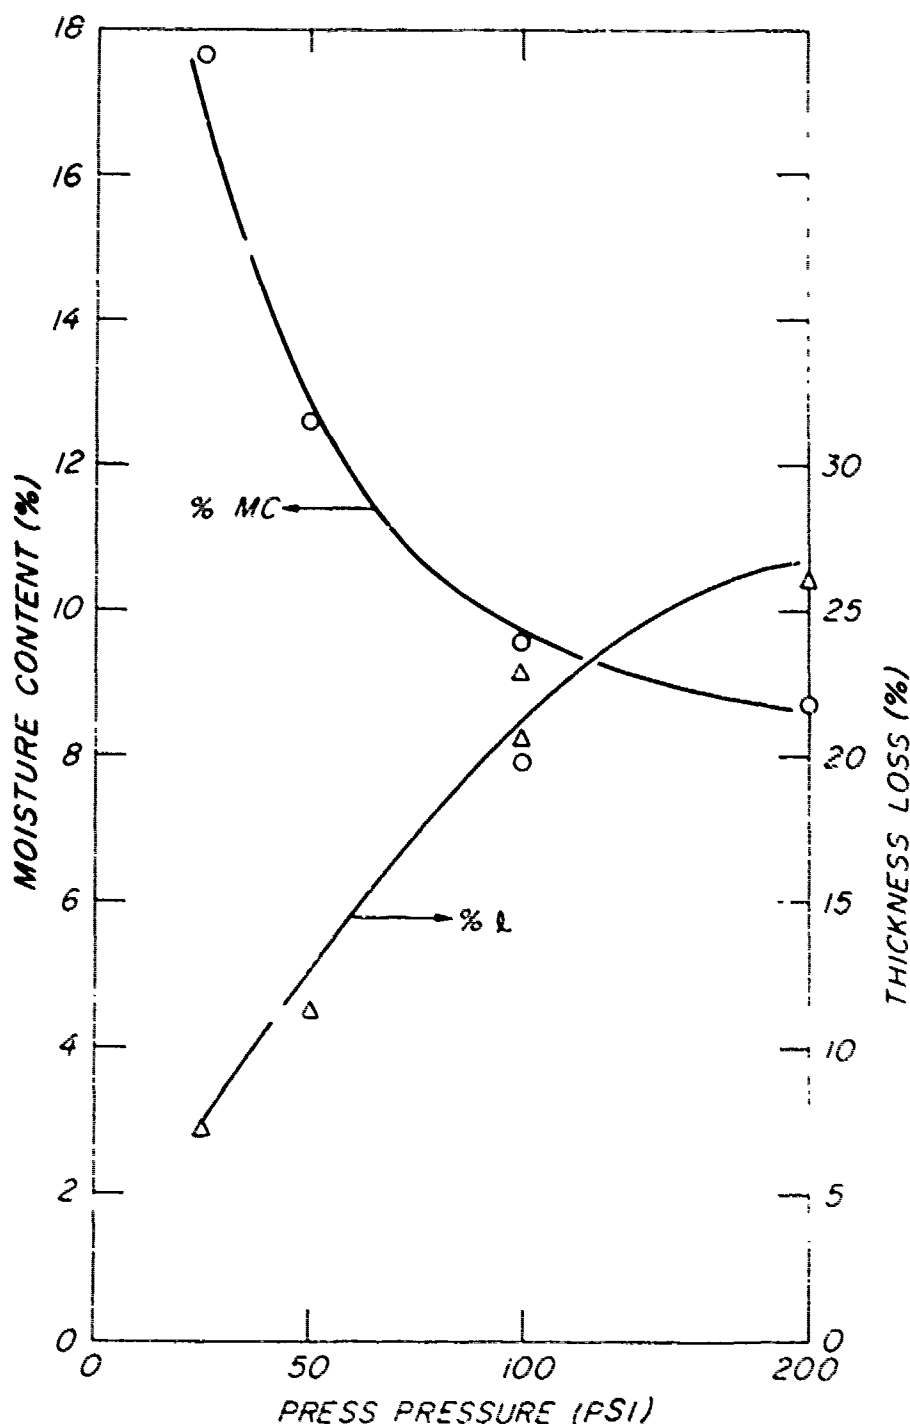
Figure 7—Percent moisture and thickness loss as a function of press dryer pressure at constant temperature and drying rate for red oak veneer (10 in. by 48 in. by 1)

$M_s = 82.3$  percent

Press: 50 inches by 50 inches (vented cauls), 375° F, 13 minutes  
Each data point average of four boards.

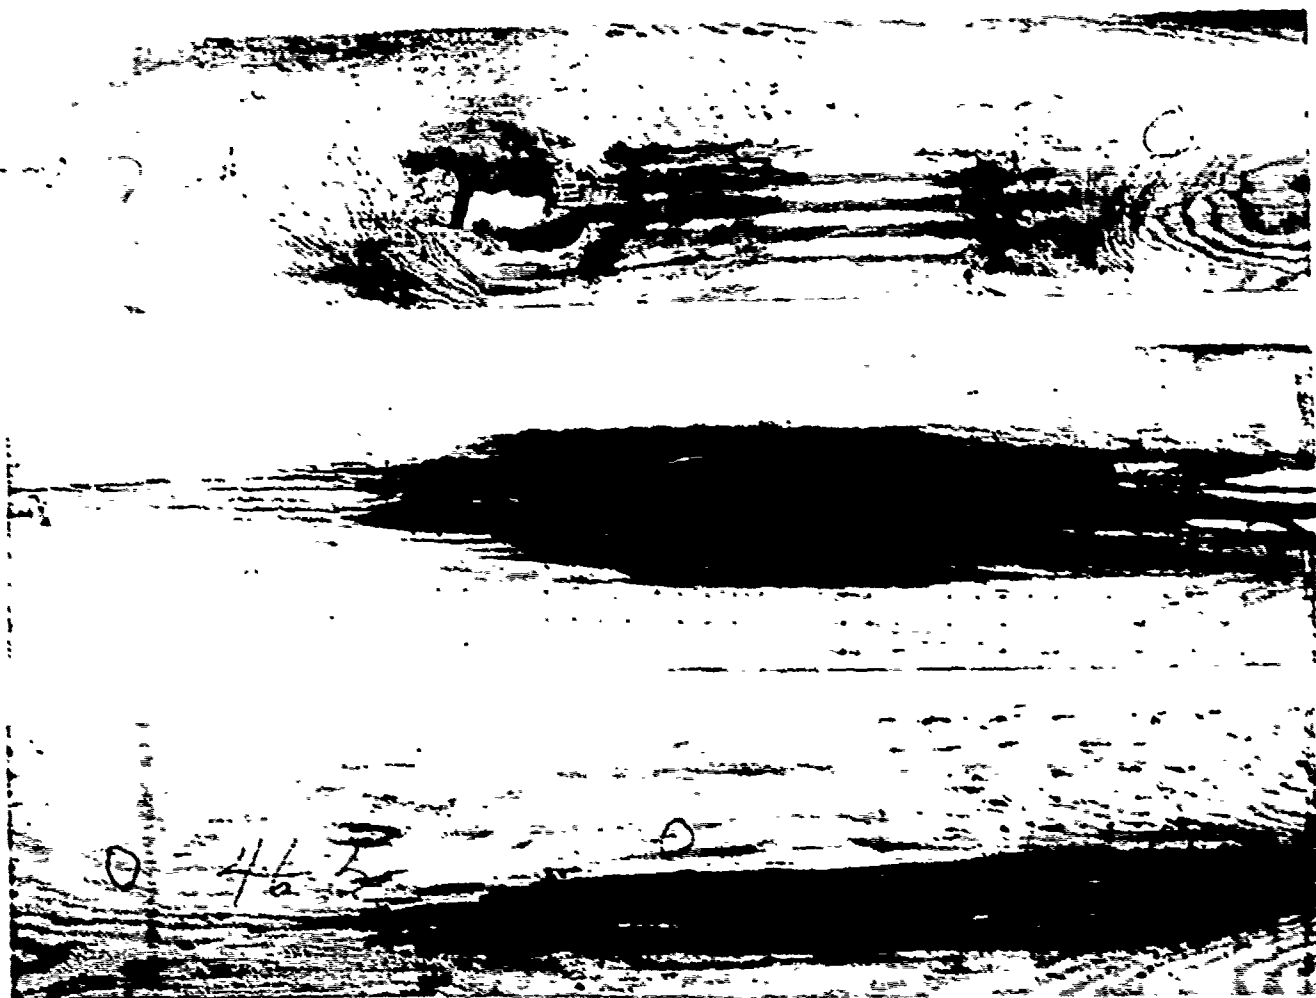
Figure 8—Appearance of red oak veneer (0.40 in.) as press dried at 200 psi, 375°F for 13 minutes showing blow-up due to insufficient venting (cauls 1/8-in. holes 1-in. o.c. square)

removed from each bolt to be used for the preliminary drying rate observations. The average moisture content of these veneers was 82 percent (range 69 to 93 pct), varying between trees. The effects of drying time (fig. 6) and pressure (fig. 7) on moisture content and thickness loss indicates that 50 psi is a good compromise for rate of drying and thickness loss. With the cauls used here (1/8-in. holes, 1-in. on center, square), this veneer blew up at 200 psi because of insufficient venting (fig. 8).

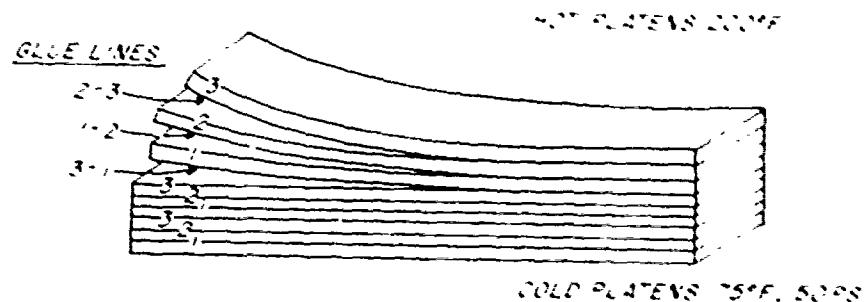
Figure 9—Schematic of subset laminae showing the positions of the glue line temperature measurements (table 2)

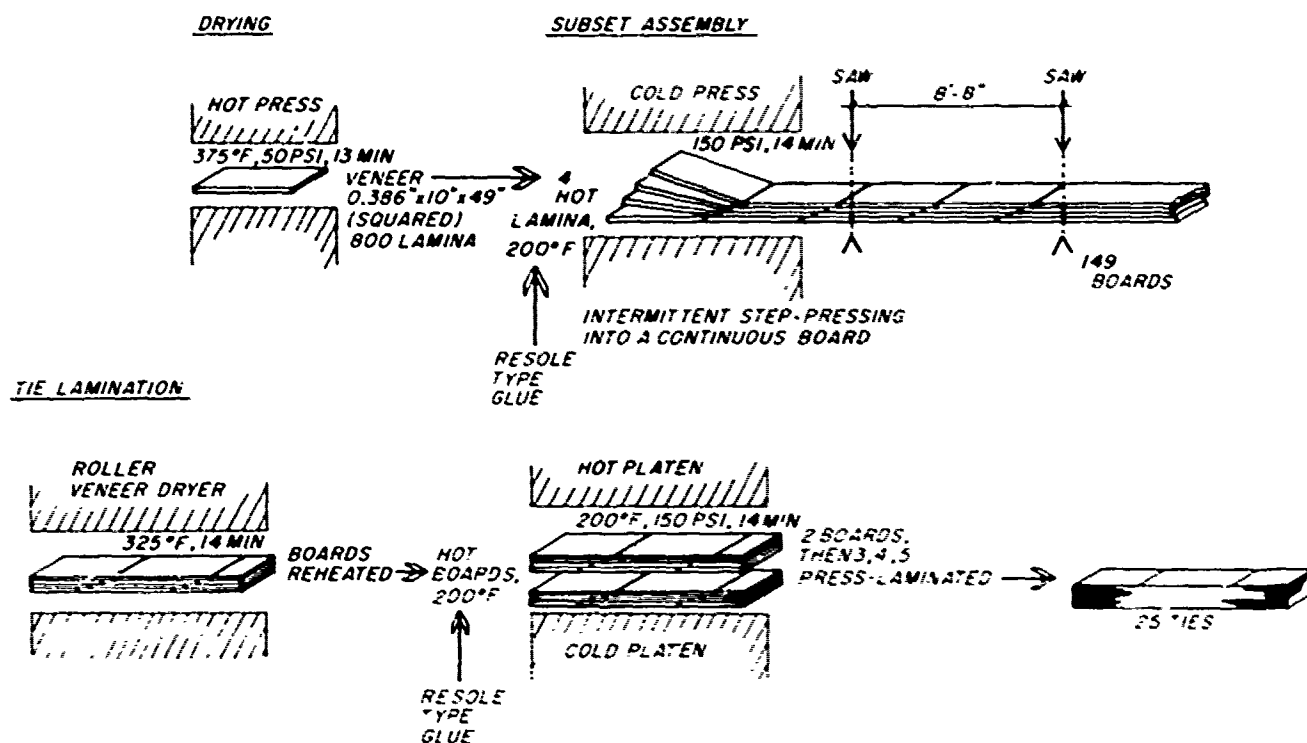
Figure 10—Process strategy in Press-Lam tie production. Drying and subset assembly of hot, 49-inch-long veneers yields boards 1.5 inches thick by 10 inches wide (note staggered butt joints between layers), and Tie laminating five hot boards in four sequential steps (four glue-lines per tie) yields one finished tie

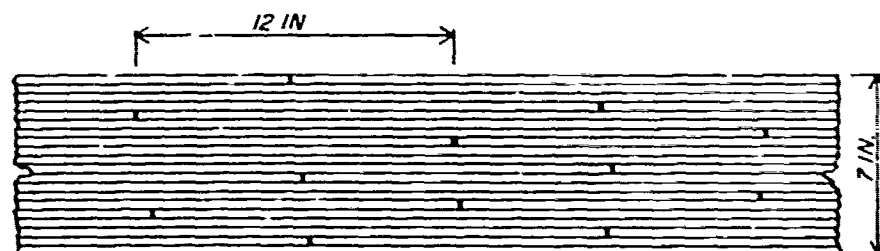
Figure 11.—Diagrammatic representation of typical butt joint locations in cross-ties produced from 4-foot-long veneer.

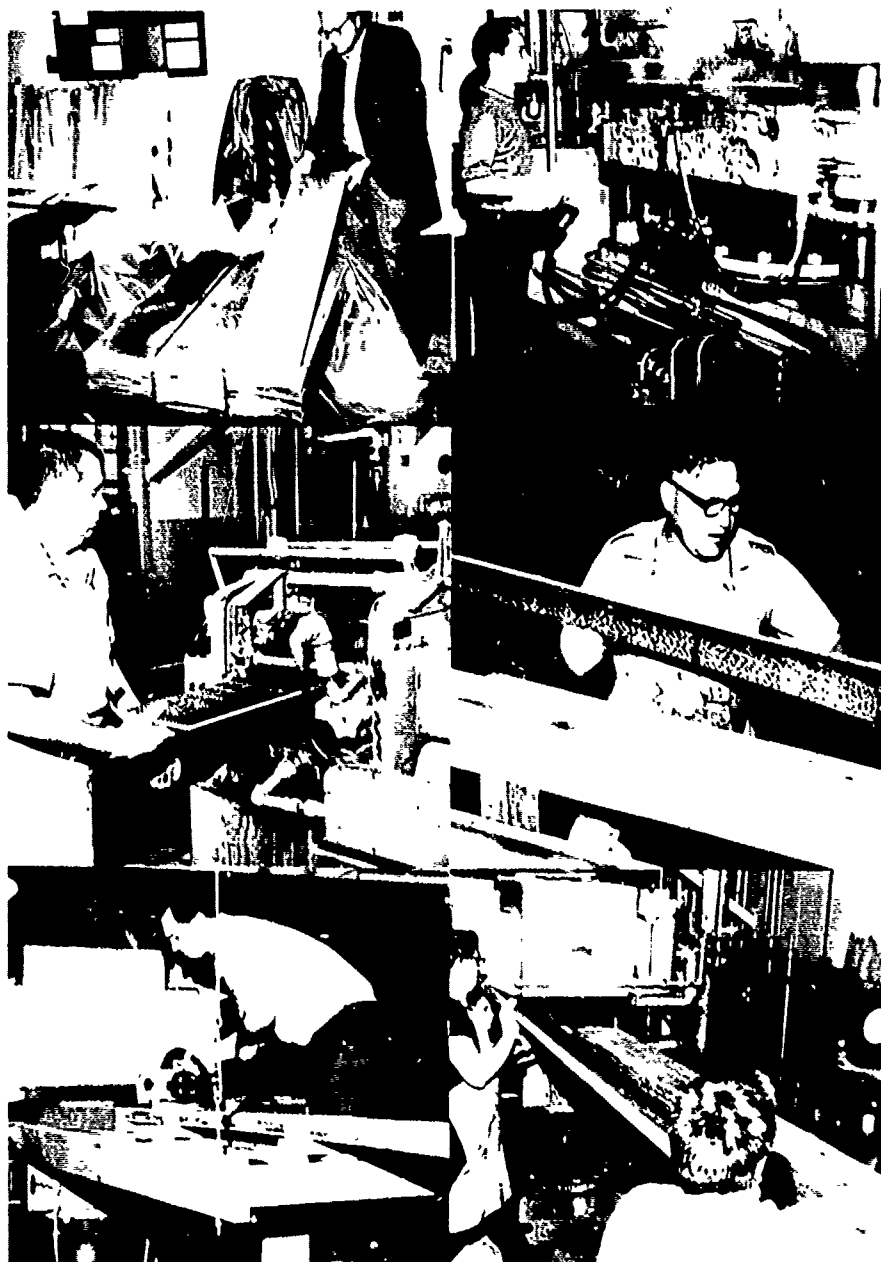
Figure 12 —Processing of 4-foot red oak veneer to crossties

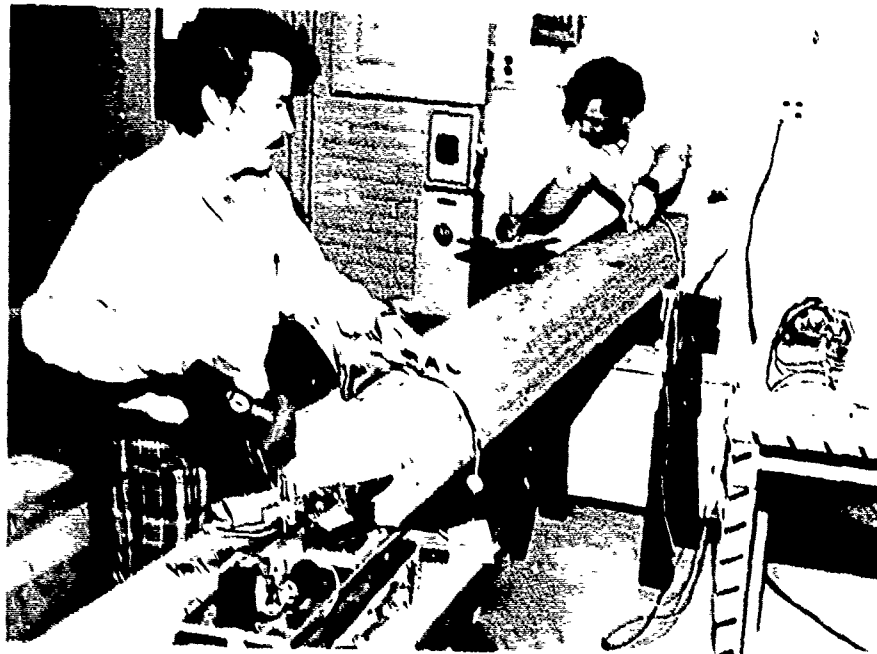
Figure 14—Stress-wave measurement on an 8-foot-veneer tie

The second procedure (on crossties of 4-ft veneer) measured the speed of transmission of an ultrasonic pulse from one end of the tie to the other. Both the transmitter and receiver were placed on the end grain with a grease couplant. As will be noted, either this procedure or the butt joints between veneer produced inconsistent readings, and the results are not reported.

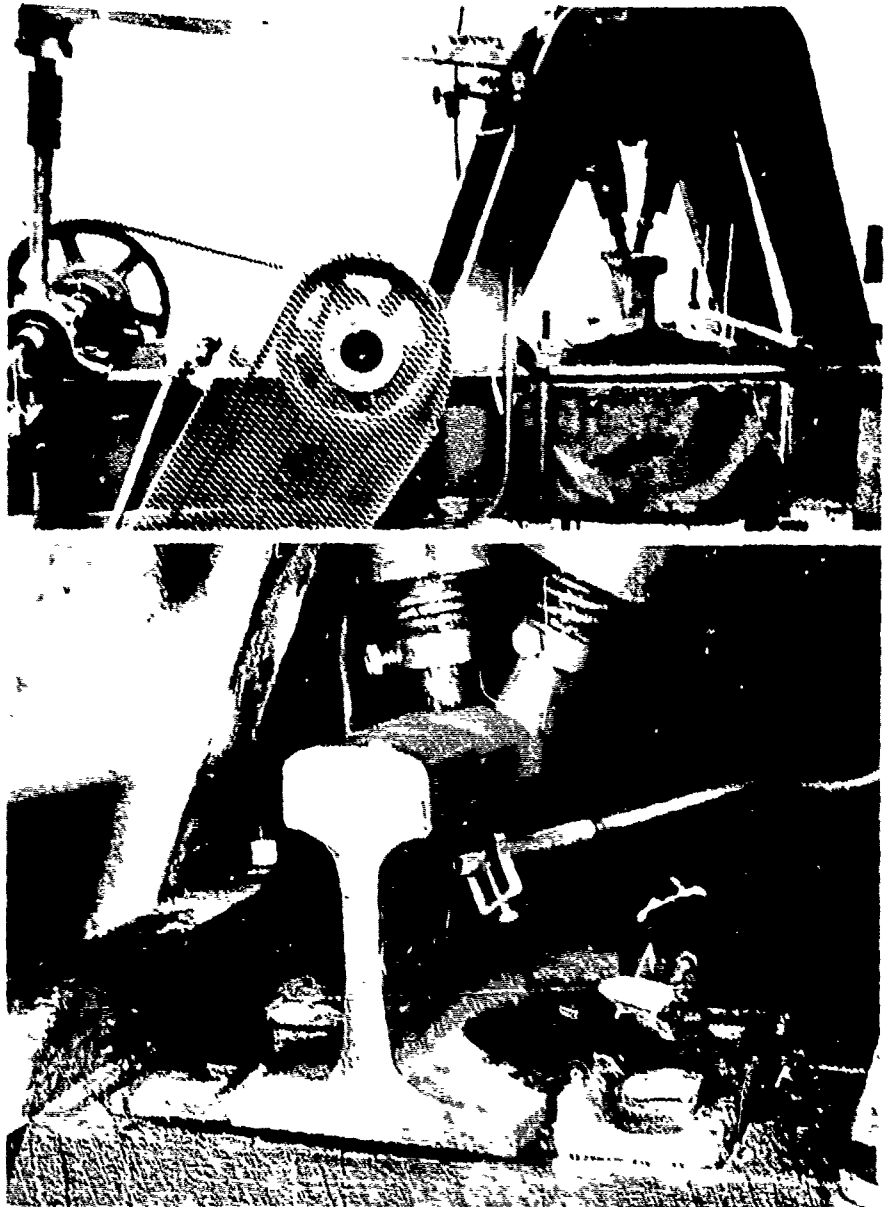
Figure 15 — Tie wear machine (upper) and close up (lower) showing grit and water dripping onto rail and tie section.

Crosstie sections from narrow ties of 8.5-foot veneer were subjected to test in an Association of American Railroads (AAR) tie wear machine (fig. 15). To conduct the test, a 14-inch steel tie plate and short length of rail are fastened to the tie section using conventional 5/8-inch spikes driven into 5/8-inch holes.

In the test, both vertical and lateral loads are applied. The lateral forces simulate the pattern of the outward and inward forces on the outer rail of a curve. A typical test with a 14-inch tie plate on a creosoted oak tie would yield average force components of 20,000

pounds vertical, 4,000 pounds inward, and 8,000 pounds outward of the track. The optimum speed of the tie wear machine is about 120 revolutions per minute. Two and one-half million cycles of alternating vertical and lateral loads constitute a full test. A constant drip of water is applied on each side of the rail and sand is added to the vacant spike holes in the plates to accelerate tie wear. No sand and water are used in the first 20-minute seating period.

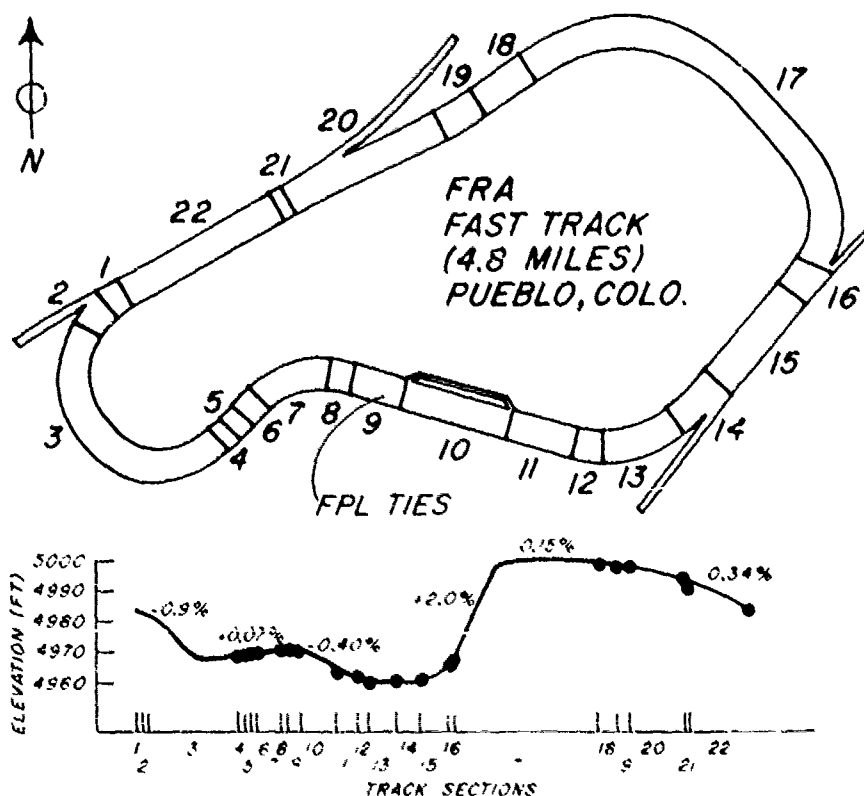
**Figure 16—Federal Railroad Administration's FAST Track layout at Pueblo, Colo., and grade for each track section. Numbers above curve indicate grade**

FAST Track installation was activated in October 1976. This accelerated evaluation test facility subjects track components to accumulated service loads ten times faster than can be achieved in commercial service. In addition, FAST Track has a higher percentage of curved track than is common in the U.S. (fig. 16), thereby increasing the potential for a higher rate of wheel and track wear. A train is continuously run over the track for 16

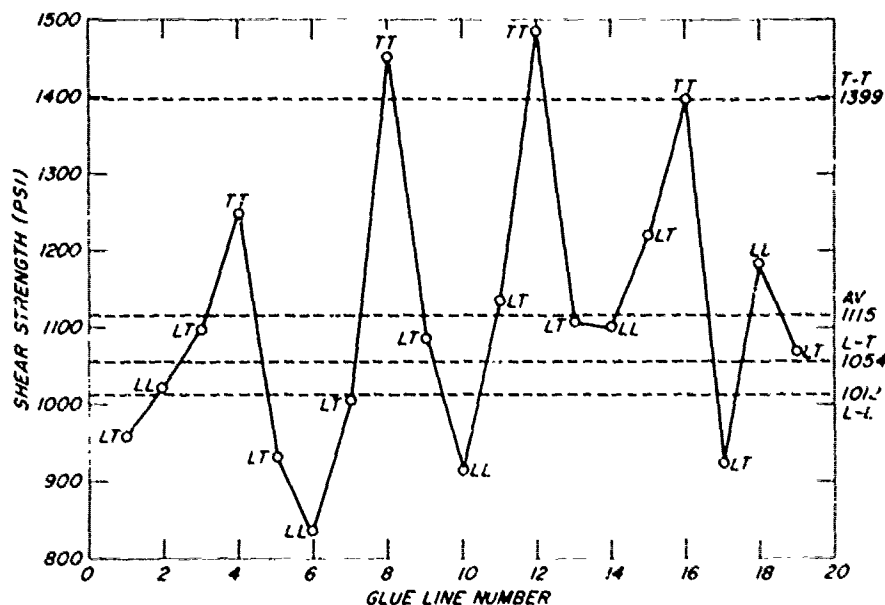
Figure 17.—Periodic shear bond strengths as a function of tight-to-tight (T-T), loose-to-tight (L-T), and loose-to-loose (L-L) types within the tie. Average for six red oak ties (each point 18-test average; 72 observations for T-T, 180 observations for L-T, 90 observations for L-L).

Bonding the loose side of the veneer considerably reduces the average shear strength and percent wood failures obtained. There are several reasons for this. The loose side is rougher and its

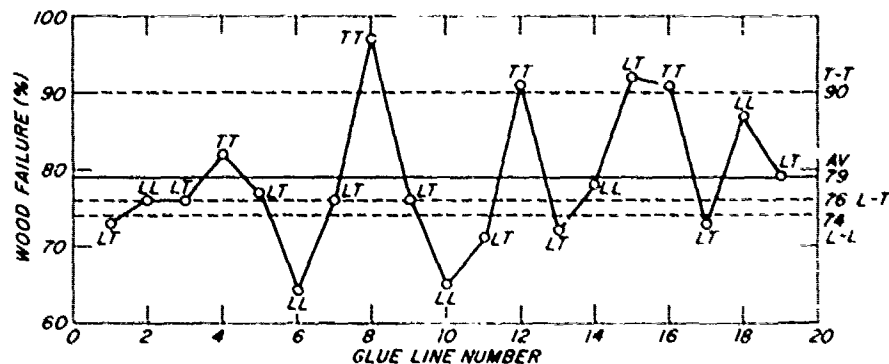
Figure 18.—Periodic percent wood failure as a function of T-T, L-T, and L-L surface types within the tie. Average for six red oak ties (each point 18-test average; 72 observations for T-T, 180 observations for L-T, 90 observations for L-L).

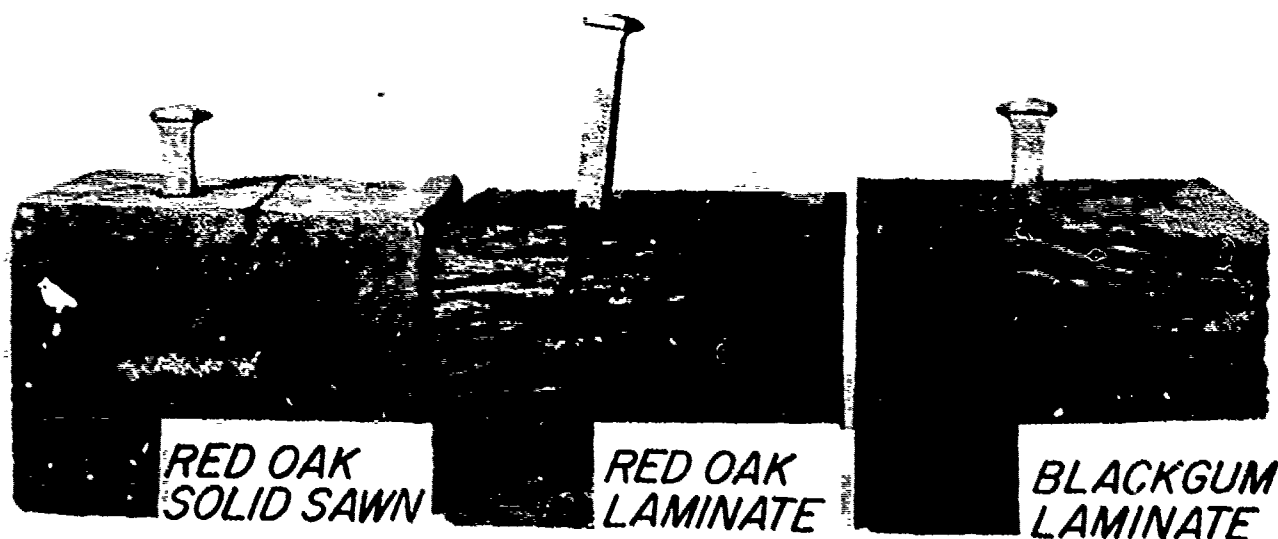
Figure 23.—A brash split occurred on driving a 5.8-inch spike 3 inches into a 9 16-inch hole in the red oak laminate. Neither the solid oak control nor the blackgum laminates split on having a spike driven 5 inches into the wood

On driving a  $\frac{3}{8}$ -inch spike 3 inches into a 9.16-inch hole in the red oak laminate, the specimen split. A piece of solid red oak of comparable moisture content, specimen size, and spike hole location did not split on driving a  $\frac{3}{8}$ -inch spike into a 9.16-inch hole. These results are indicative of a potential problem, but are inconclusive.

In contrast, the blackgum laminate showed no open lathe checks either at the ends or internally. When the spike was driven into a 9.16-inch hole, no internal cracks were developed in the blackgum laminate (figs. 22 and 23).

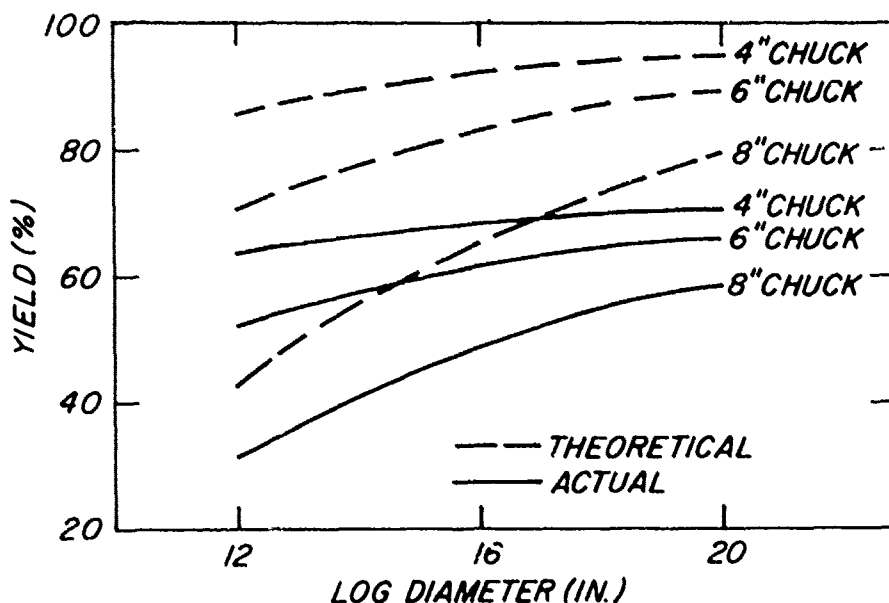
Figure 24.—Effect of log diameter on yield from three chuck sizes.

$$\text{Efficiency} = \frac{\text{Actual yield}}{\text{Theoretical yield}} \times 100 \text{ percent.}$$

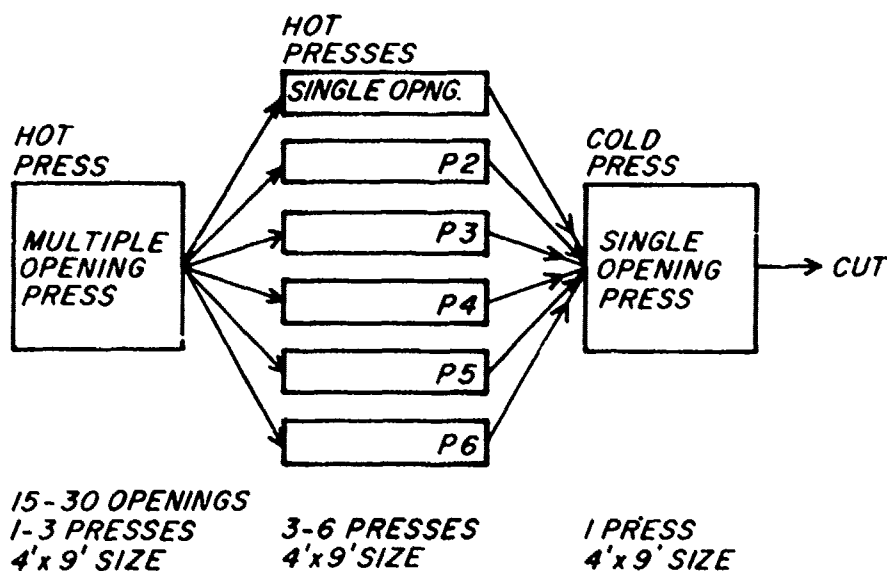
Figure 25.—One scheme for processing Press-Lam cross-ties from 8.5-foot veneer. Billets 4 by 9 feet by 7 inches thick are produced and resawn into 7- by 9-inch by 9-foot cross-ties.
